CONNECTICUT RIVER BASIN
CLAREMONT, NEW HAMPSHIRE

COY DAM

NH 00140

PHASE I INSPECTION REPORT
NATIONAL DAM INSPECTION PROGRAM

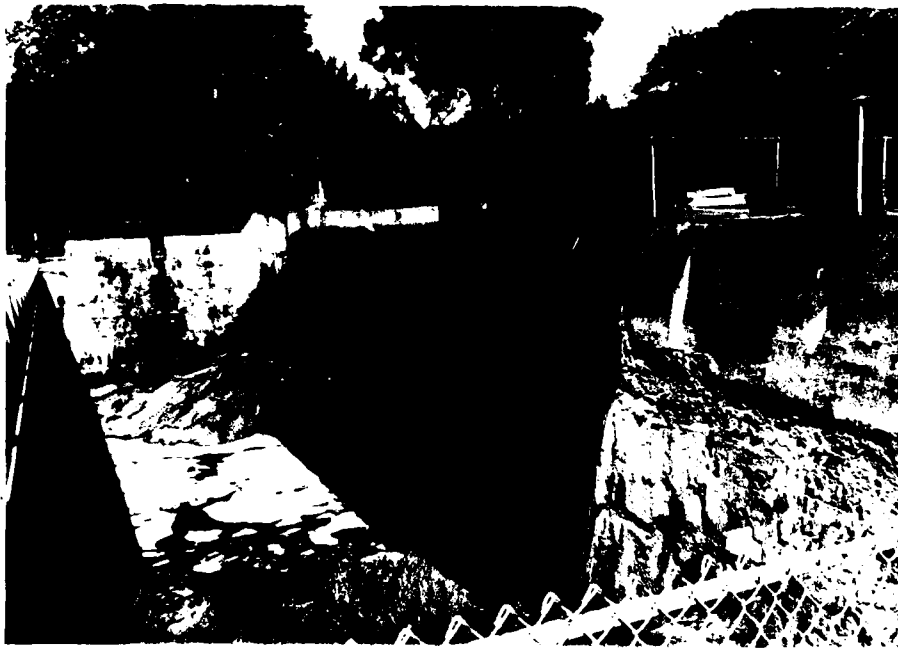
PHOTO NO. 7 - General view of spillway from left abutment.

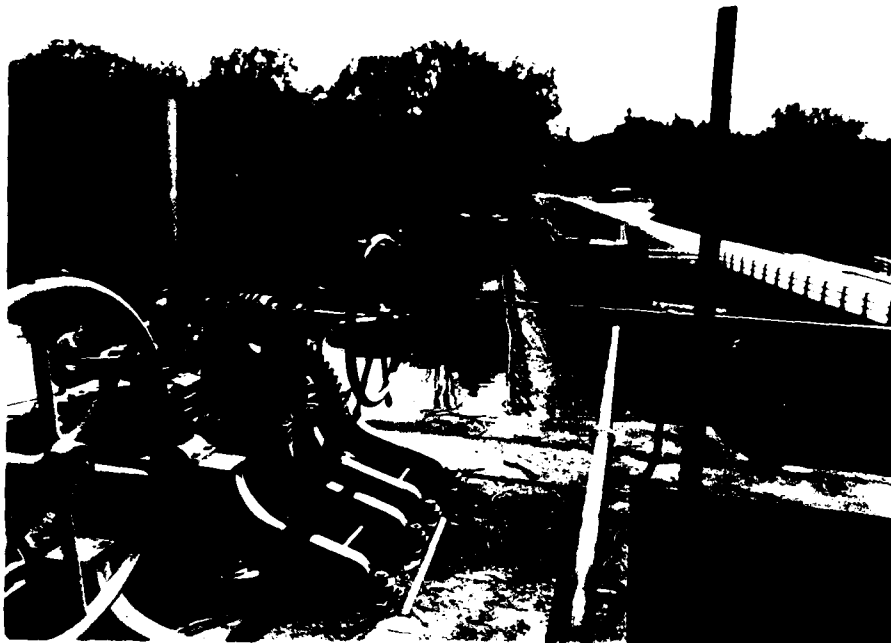
PHOTO NO. 3 - General view of dam and power intake structure from process intake structure.

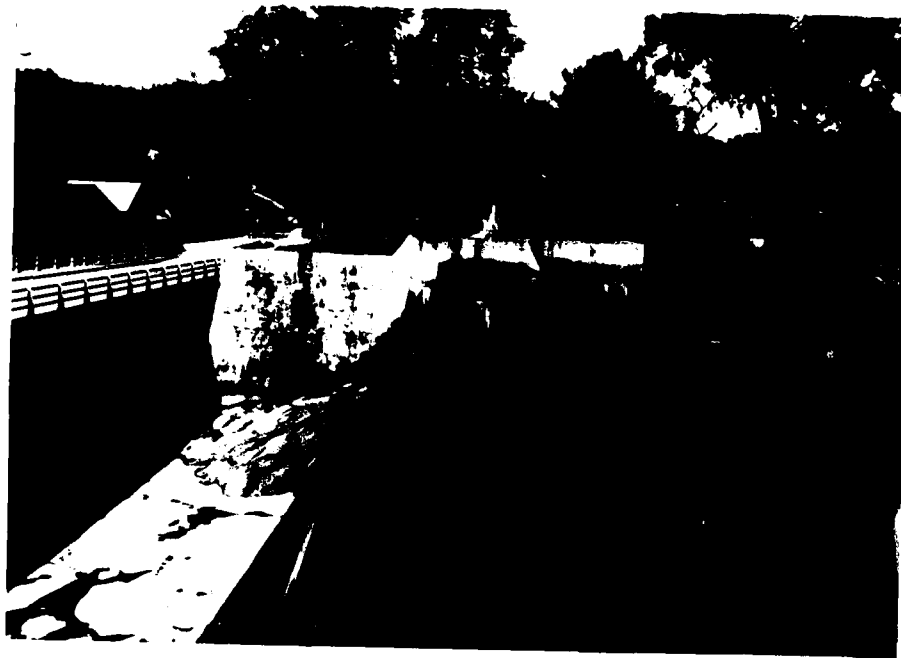
PHOTO NO. 2 - General view of dam and process intake structure from power intake structure.

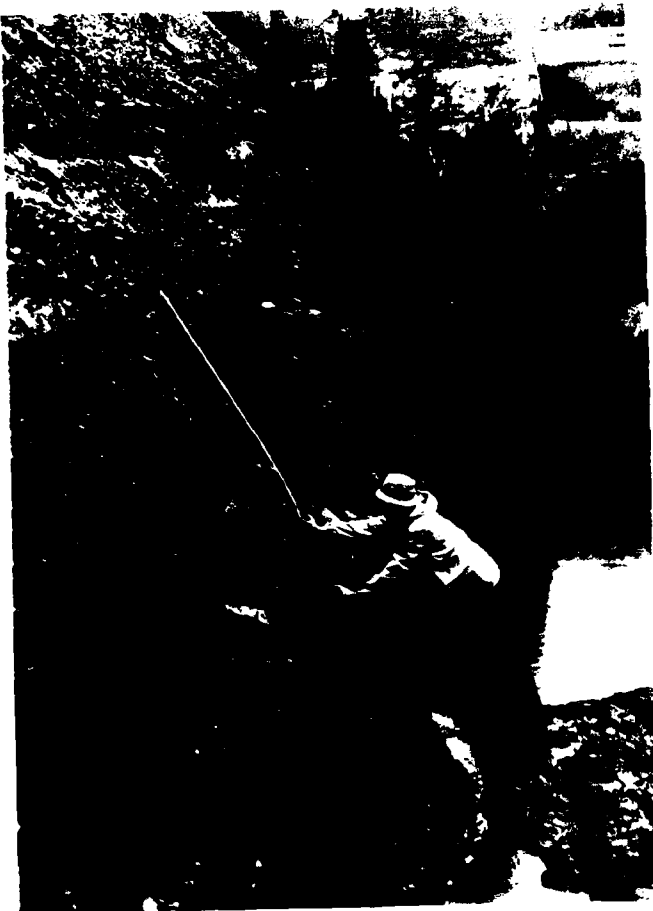
According to available construction specifications, the concrete used for the spillway construction consisted of approximately three bags of cement per cubic yard of concrete. Construction specifications also indicate that a 1 inch cement/sand mortar was used as a bonding material between construction joints. Visual inspection disclosed a silt deposit at the upstream face of the dam to a height approximately 2 feet below the crest of the spillway. Based on the present operational conditions and silt deposits, as above mentioned, it appears that the upstream face of the spillway section may be in tension. The presence of tension cracks in the upstream face of the spillway section could have a direct relationship to the water seepage through the spillway section.

PHOTO NO. 10 - Close-up view
of spillway surface. Photo
taken from downstream
channel. Note distance
between rule and face of
spillway is about 12 inches.

(b) Design remedial measures for the badly scoured and deteriorated concrete spillway including the elimination of seepage and silt deposits.
